DOT/FAA/AR-95/108

Characterization of Early Stages of Corrosion Fatigue in Aircraft Skin

February 1996

Final Report

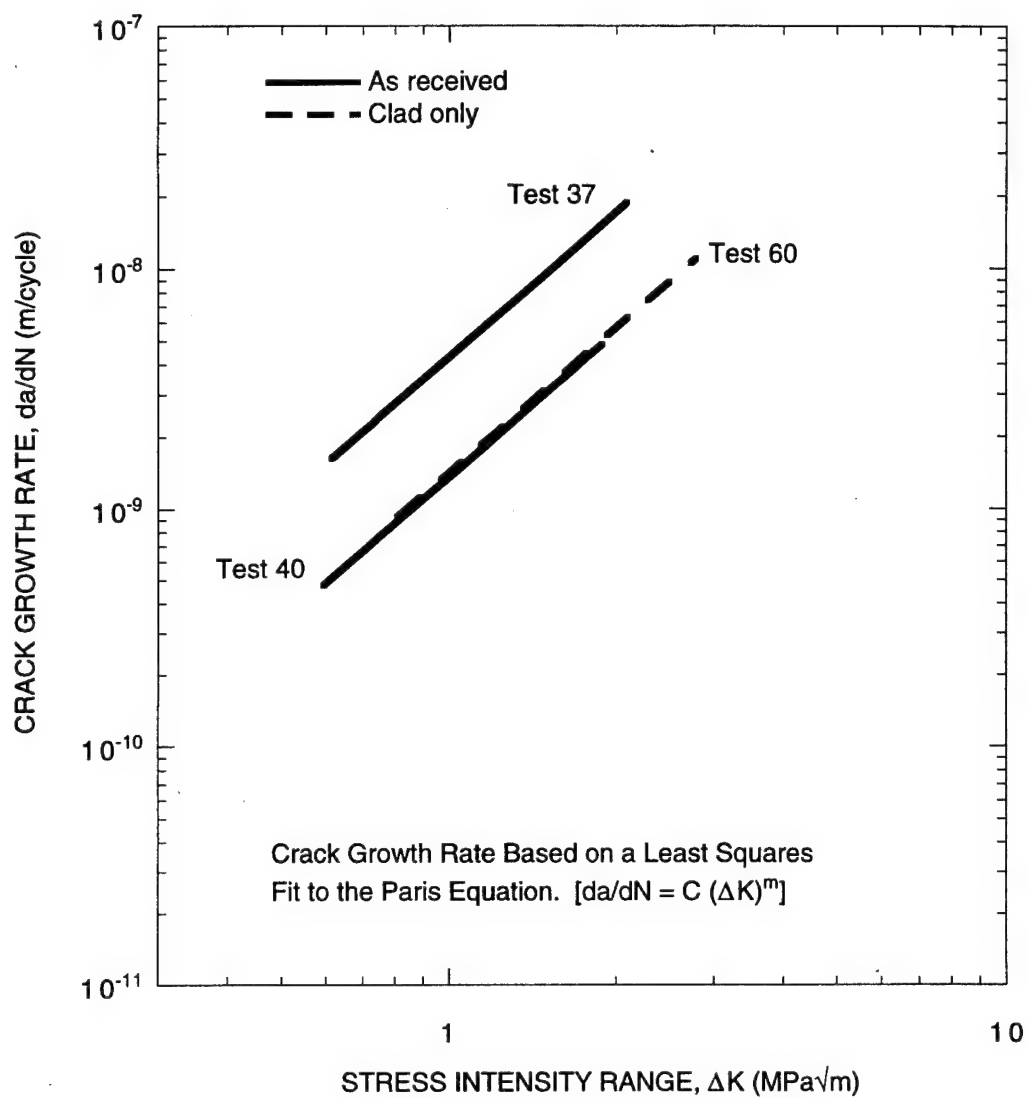
(a) Comparison of specimens in the vertical orientation with a 5 μm polish on the through-thickness surfaces in the pH 2 environment

Figure 29. Effect of surface coating on the crack growth rate of small cracks in aircraft skin.

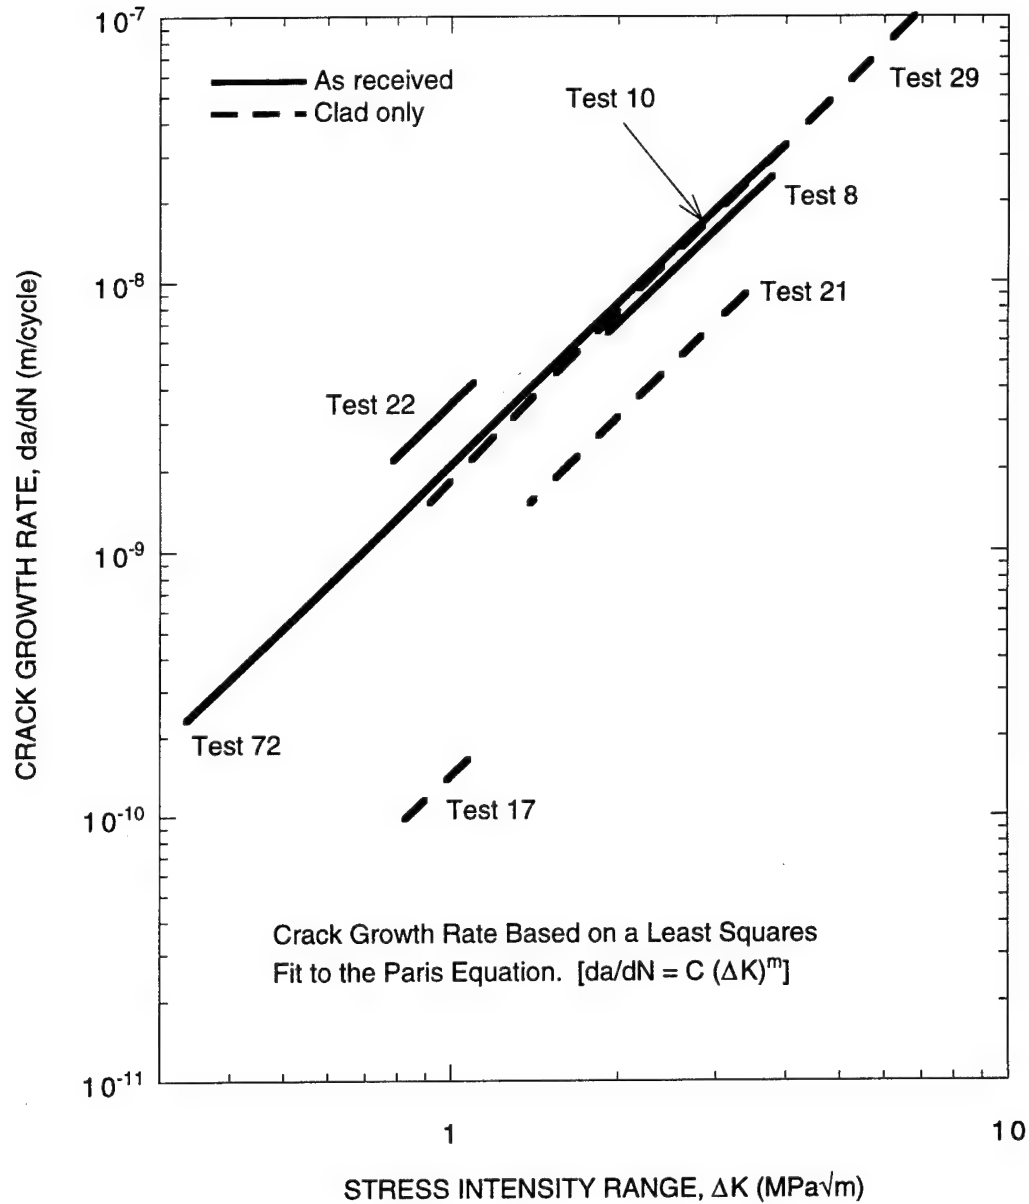
(b) Comparison of specimens in the vertical orientation with a 5 μ m polish on the through-thickness surfaces in the pH 6 environment

Figure 29. Effect of surface coating on the crack growth rate of small cracks in aircraft skin (Continued).

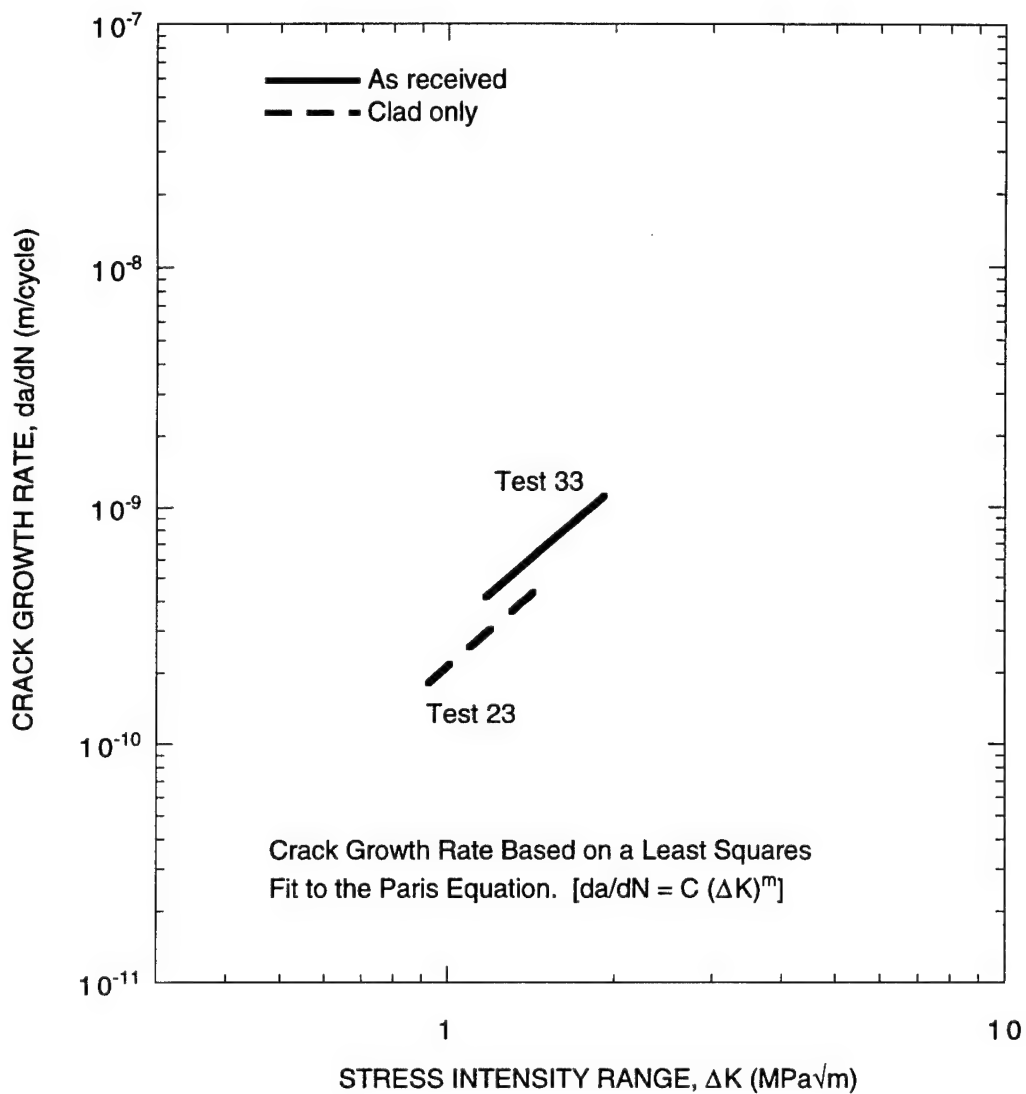
(c) Comparison of specimens in the vertical orientation with a 30 μm polish on the through-thickness surfaces in the pH 6 environment

Figure 29. Effect of surface coating on the crack growth rate of small cracks in aircraft skin (Continued).

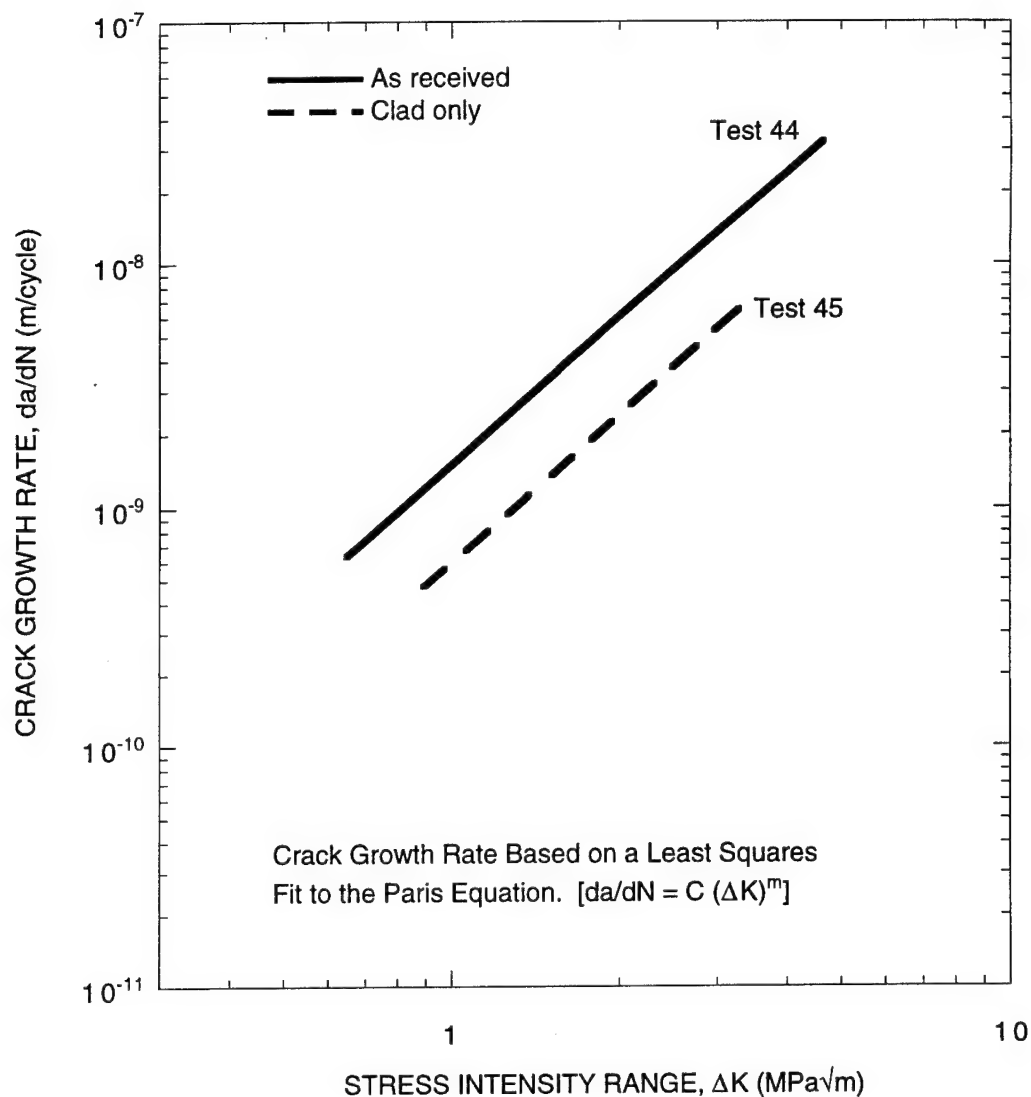
(d) Comparison of specimens in the horizontal orientation with a 30 μm polish on the through-thickness surfaces in the pH 10 environment

Figure 29. Effect of surface coating on the crack growth rate of small cracks in aircraft skin (Concluded).

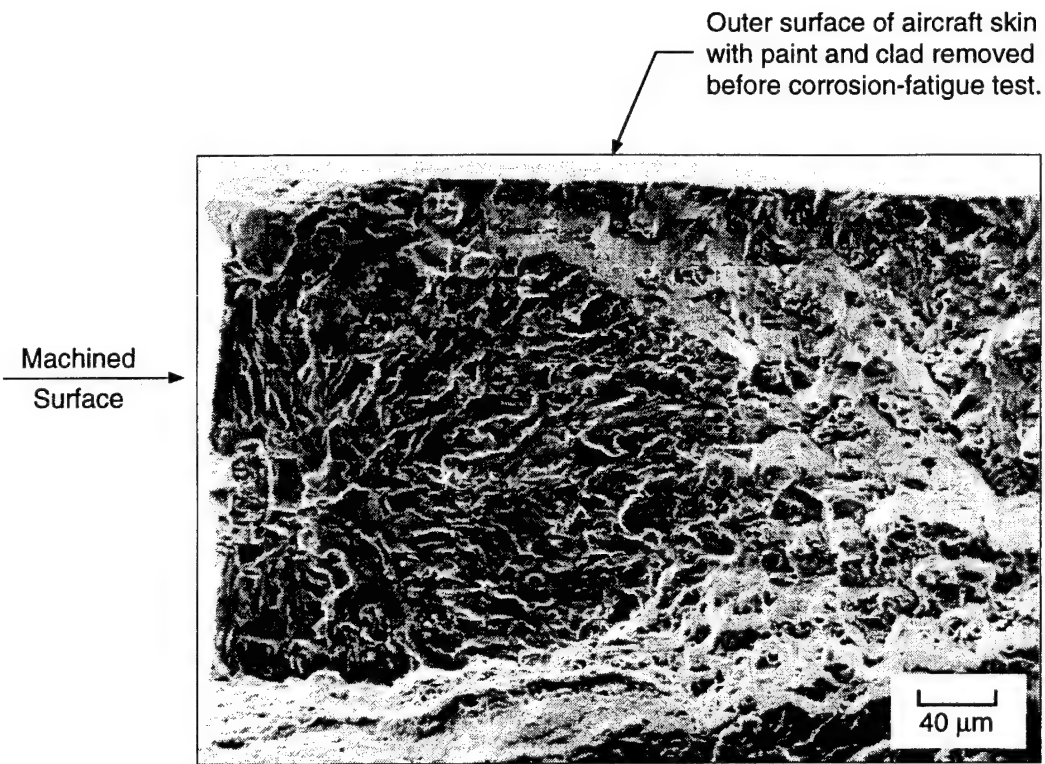
(a) Fracture surface showing corrosion-fatigue crack nucleation at pit

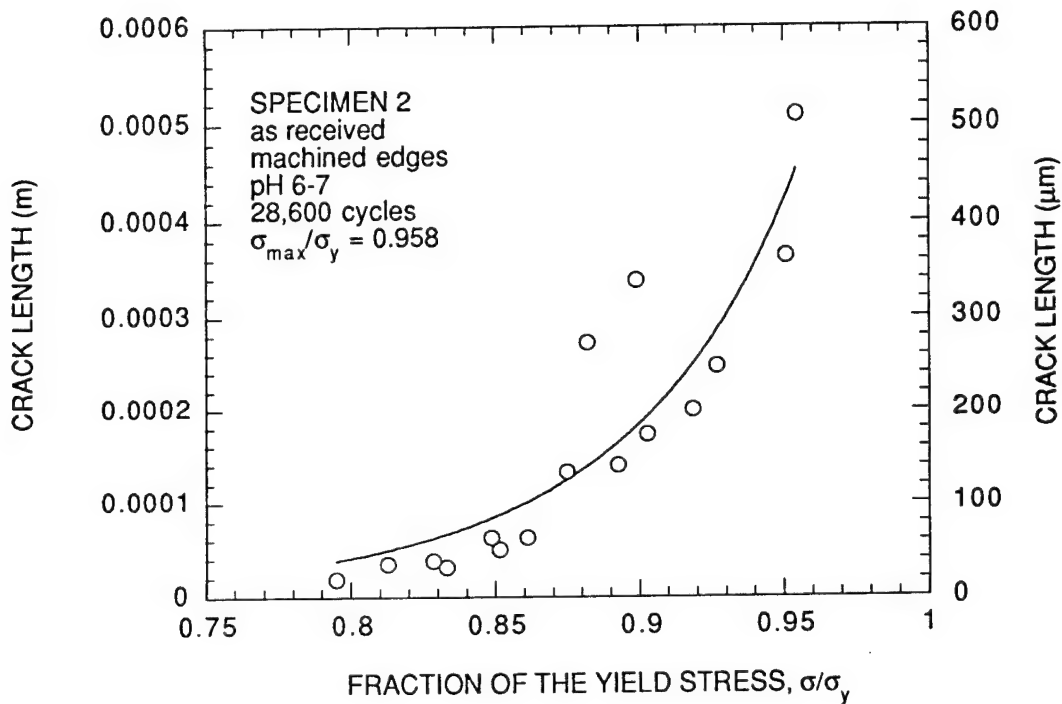
Figure A-1. Crack length data measurements and the least squares fit for Test 2.

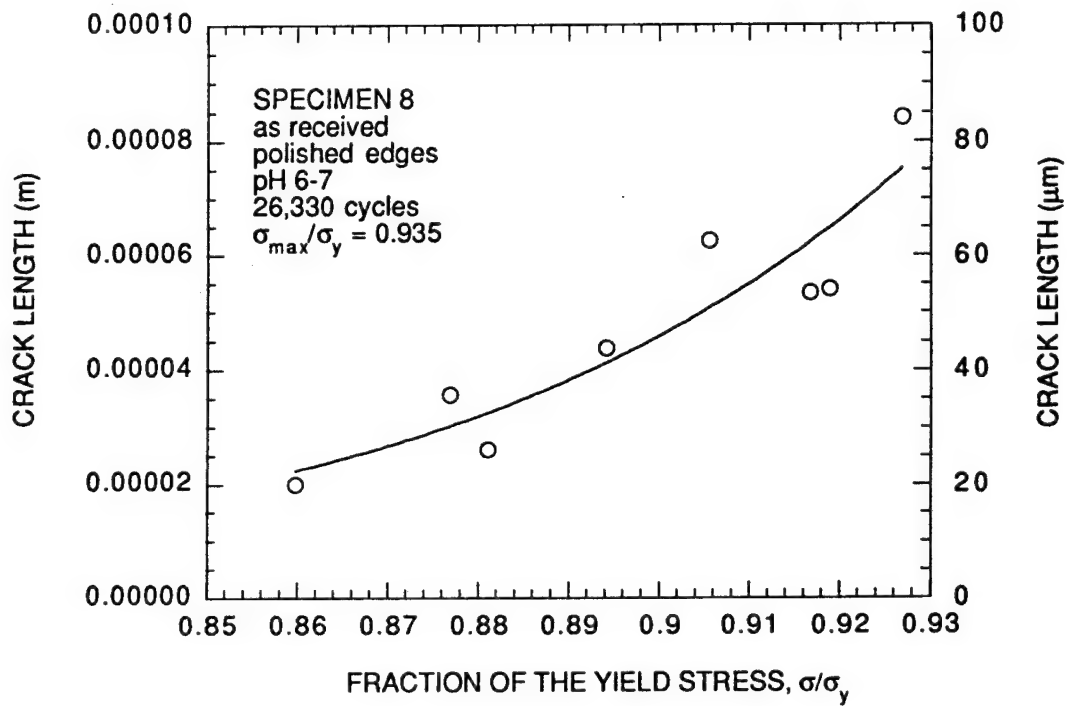
Figure A-5. Crack length data measurements and the least squares fit for Test 8.

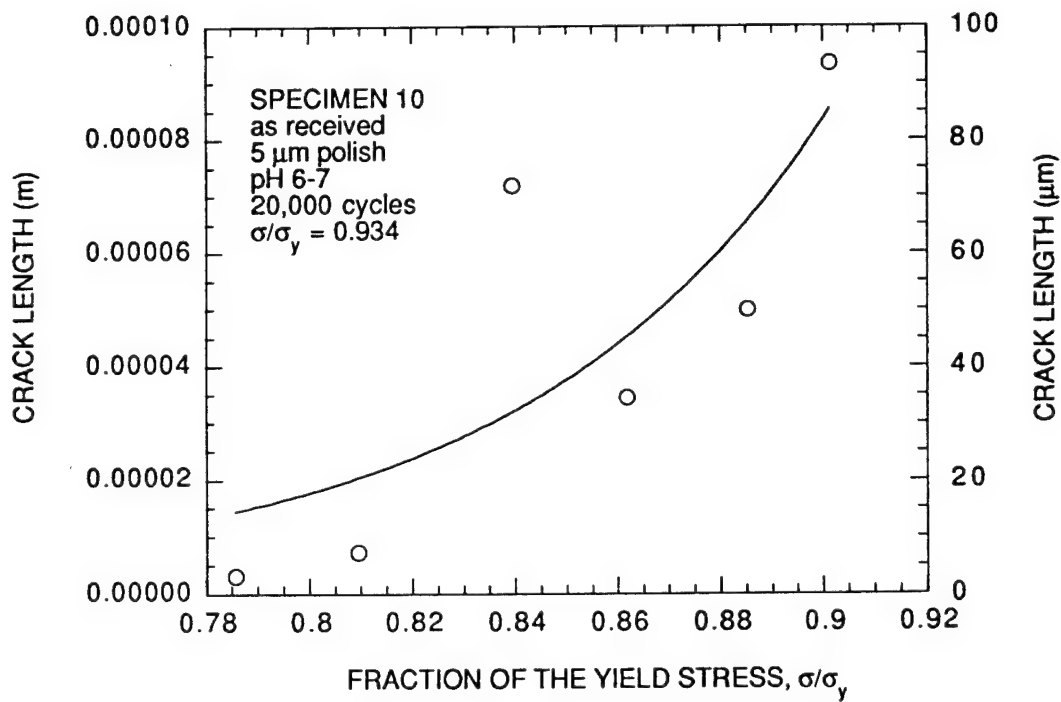
Figure A-6. Crack length data measurements and the least squares fit for Test 10.

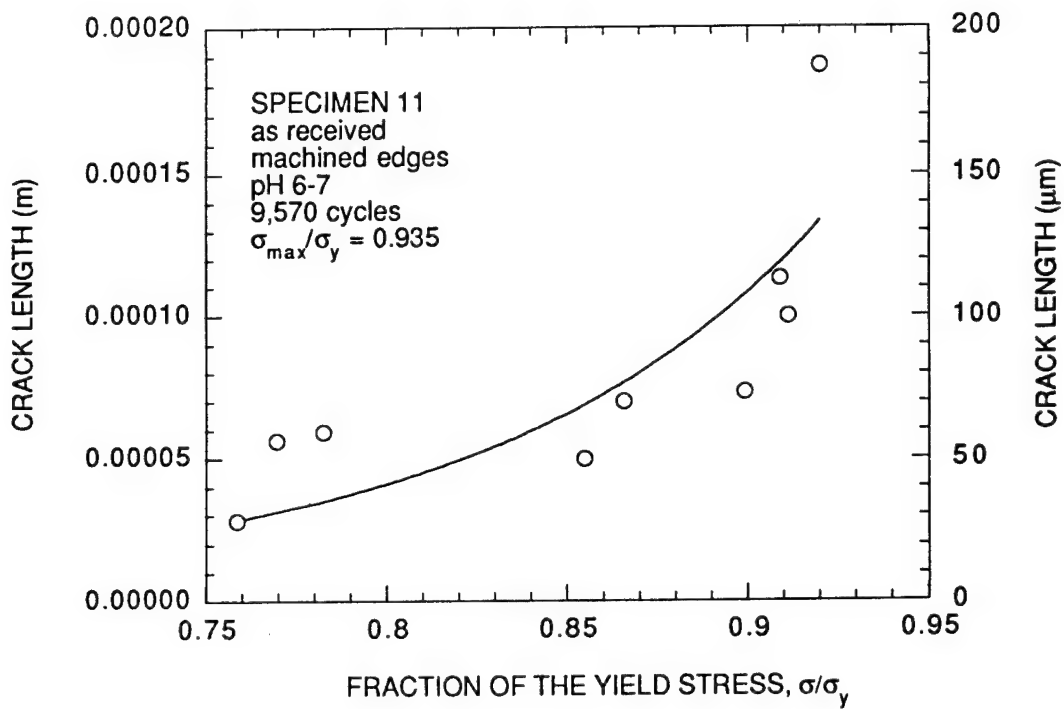
Figure A-7. Crack length data measurements and the least squares fit for Test 11.

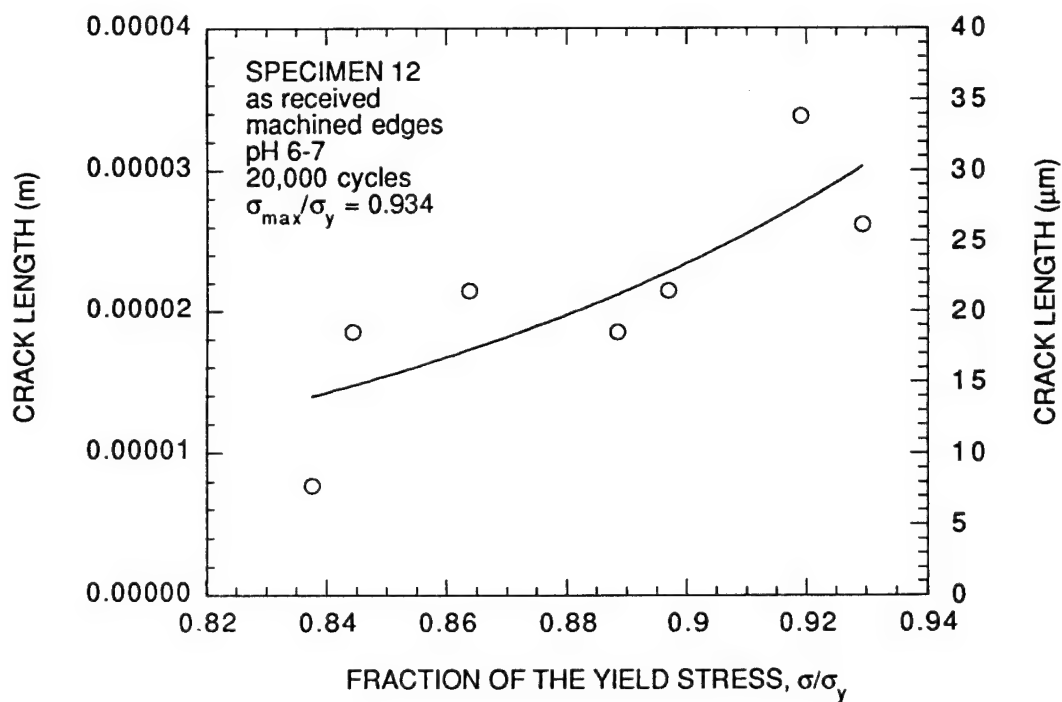
Figure A-8. Crack length data measurements and the least squares fit for Test 12.

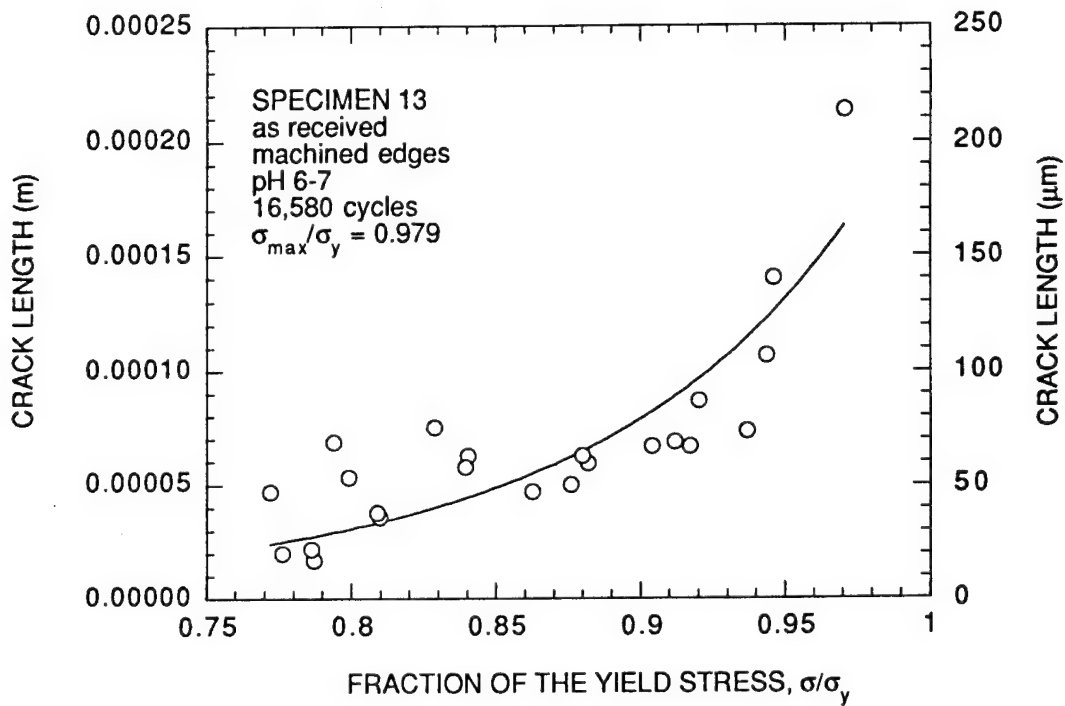
Figure A-9. Crack length data measurements and the least squares fit for Test 13.

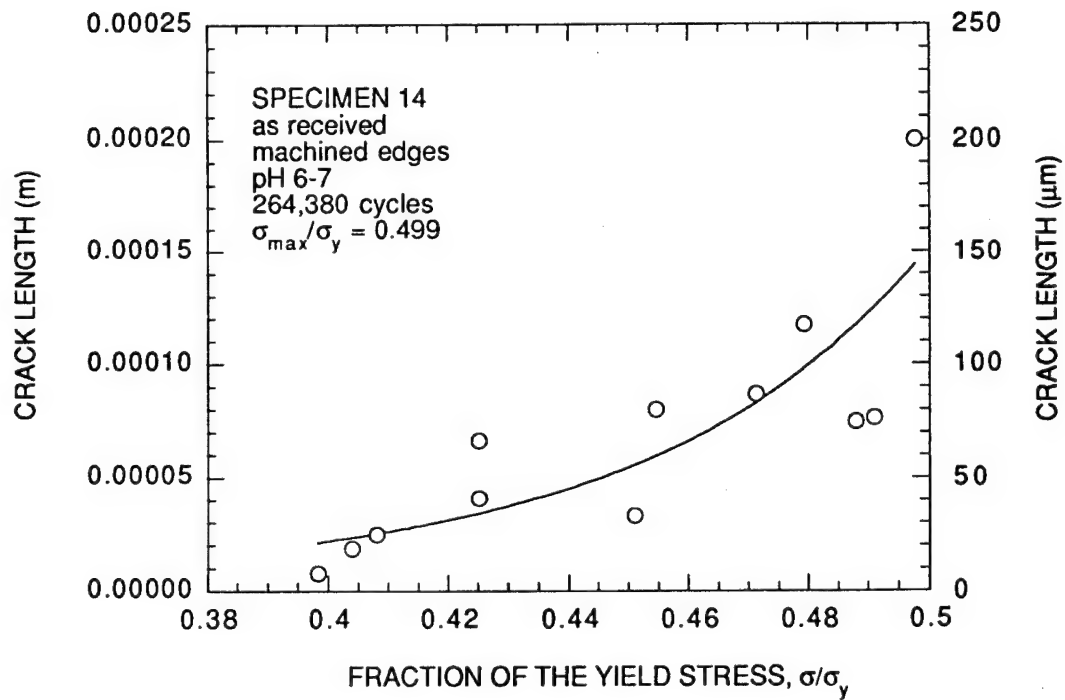
Figure A-10. Crack length data measurements and the least squares fit for Test 14.

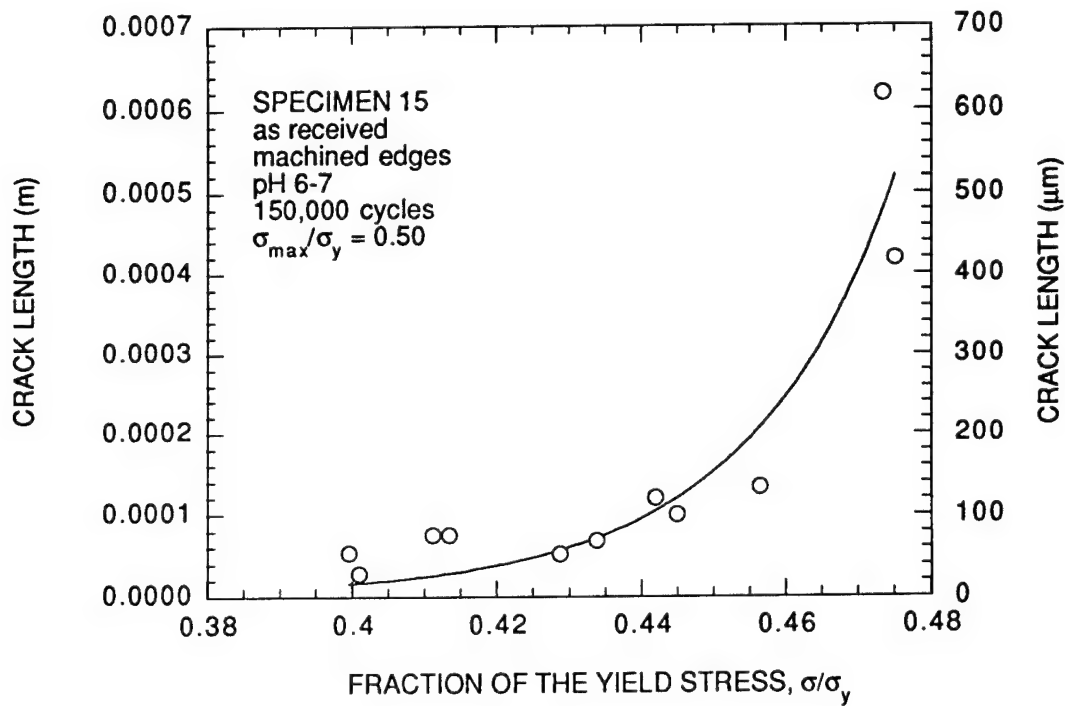
Figure A-11. Crack length data measurements and the least squares fit for Test 15.

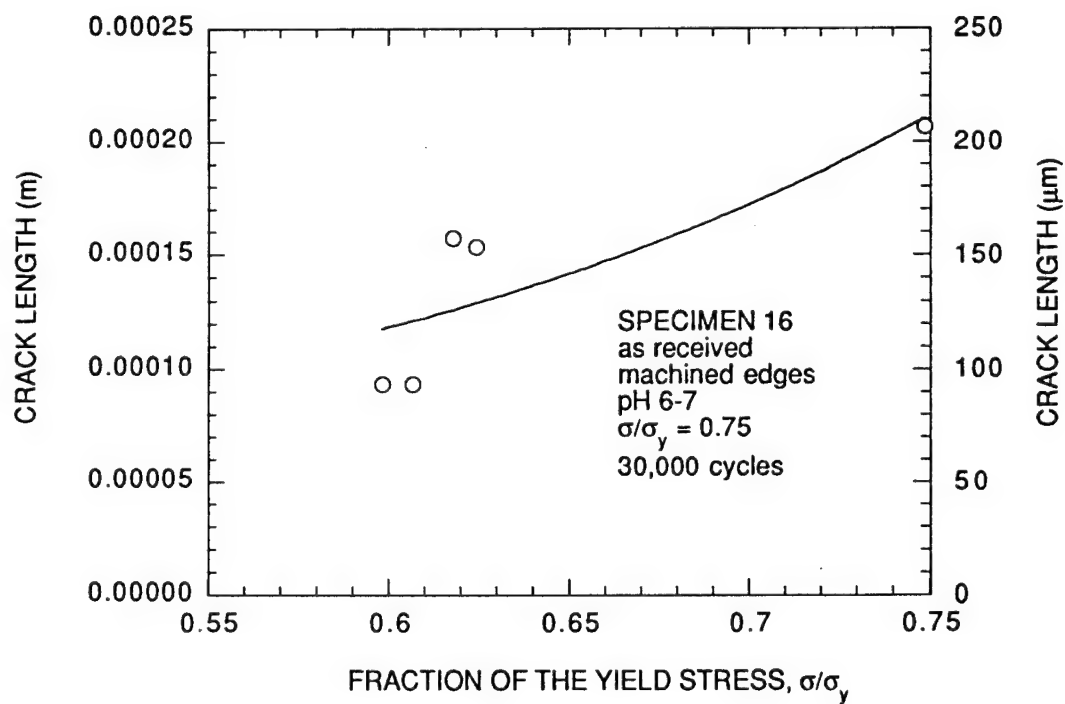
Figure A-12. Crack length data measurements and the least squares fit for Test 16.

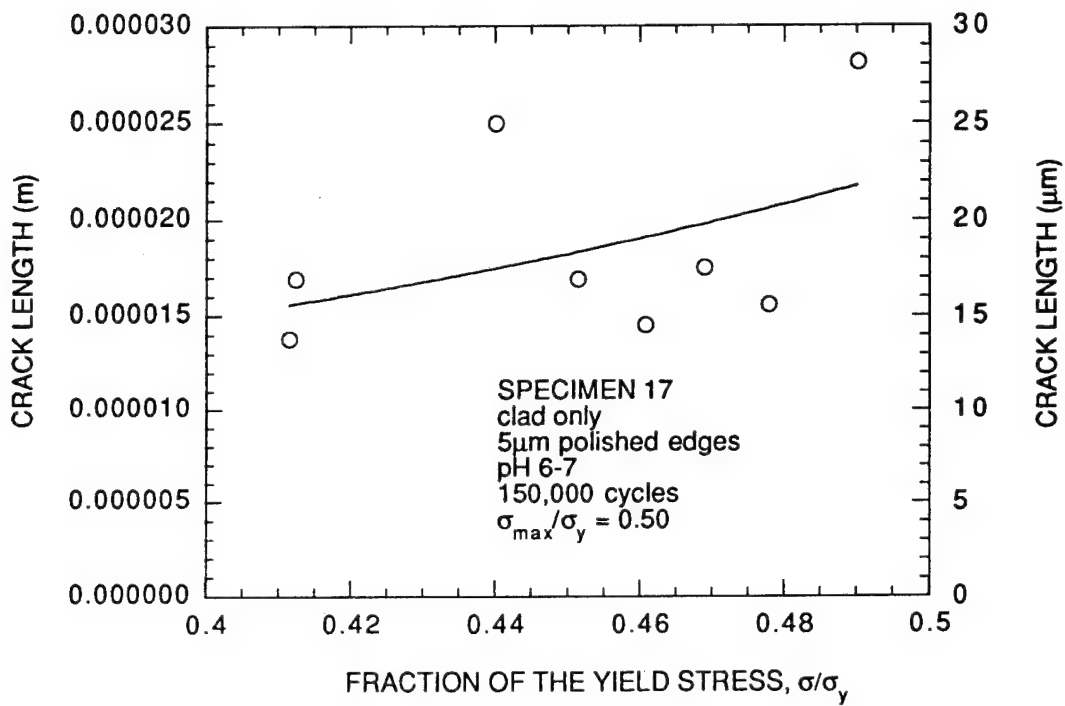
Figure A-13. Crack length data measurements and the least squares fit for Test 17.

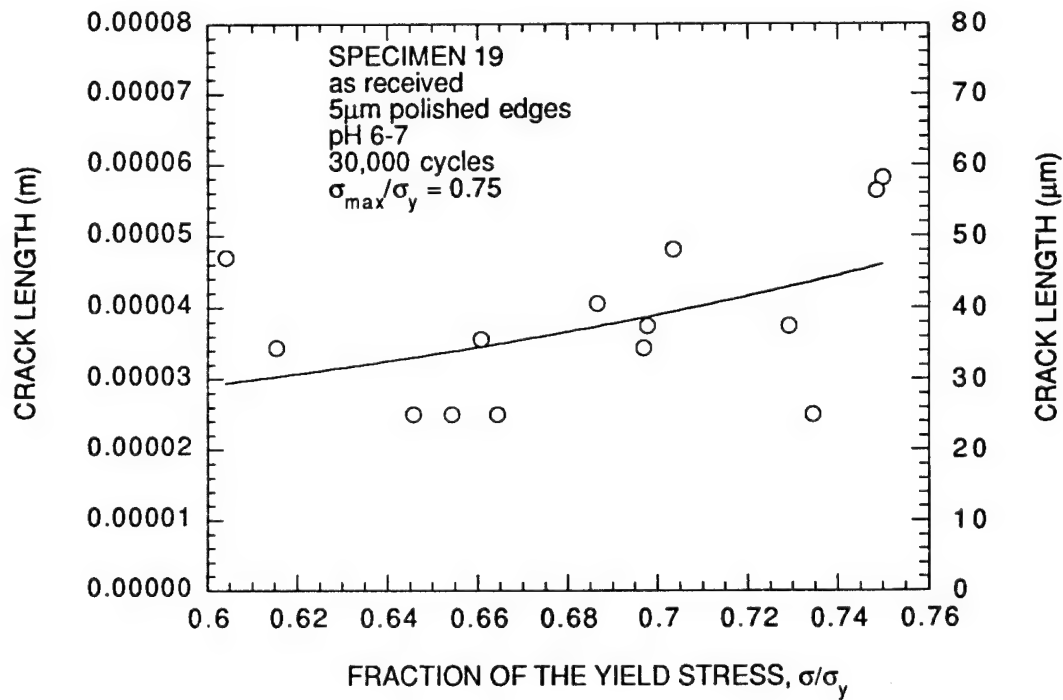
Figure A-14. Crack length data measurements and the least squares fit for Test 19.

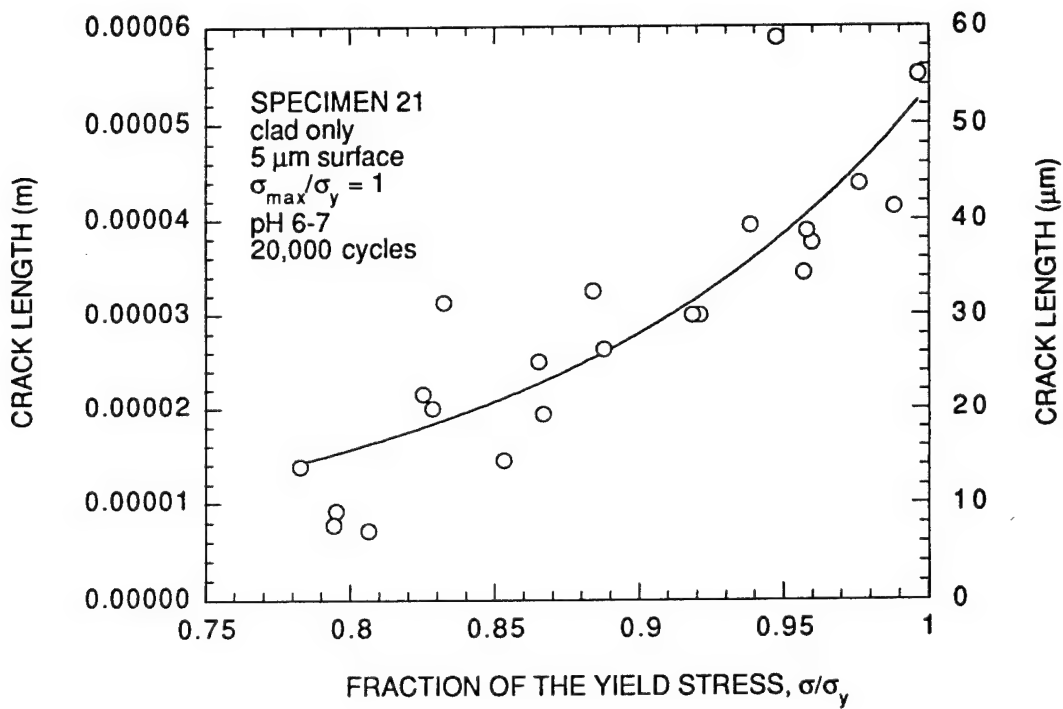
Figure A-15. Crack length data measurements and the least squares fit for Test 21.

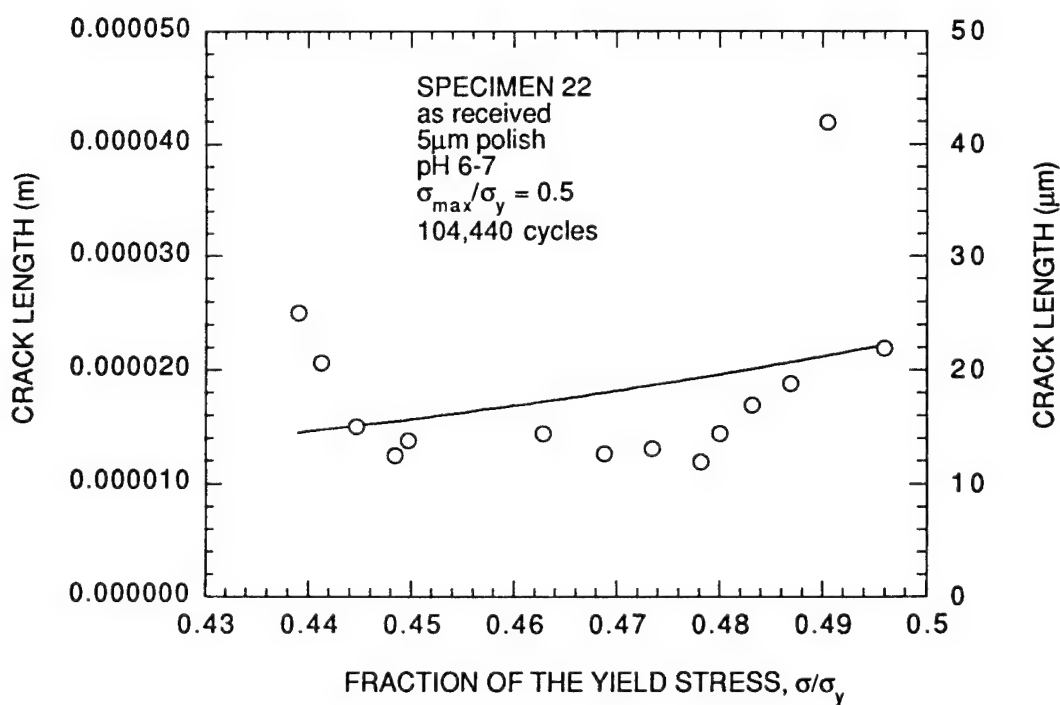
Figure A-16. Crack length data measurements and the least squares fit for Test 22.

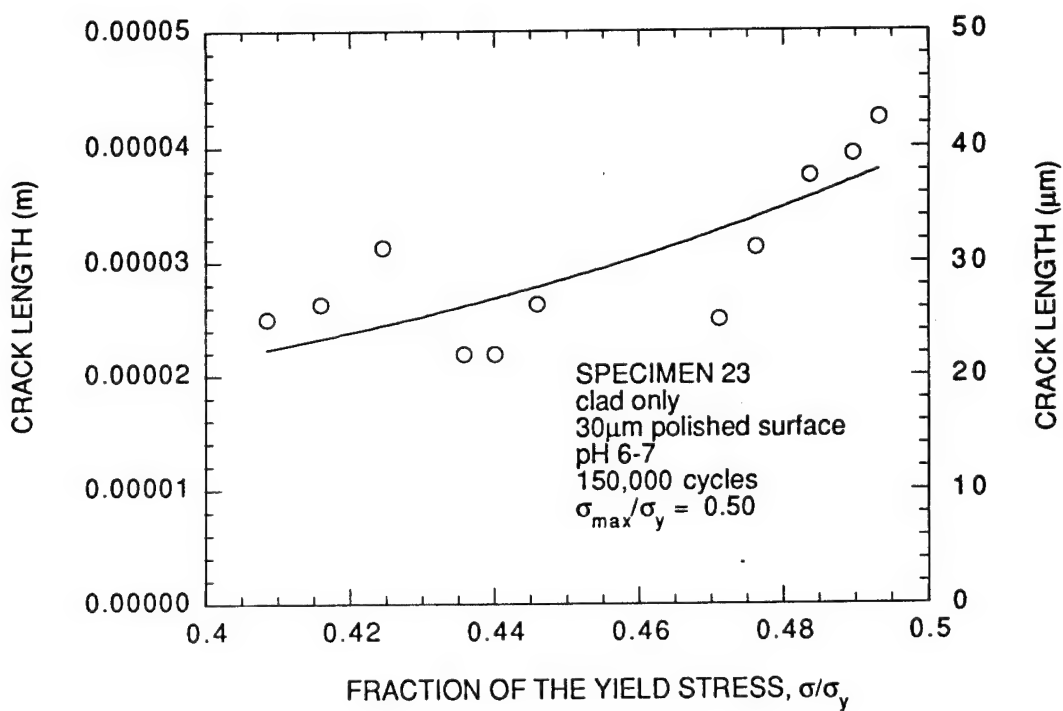
Figure A-17. Crack length data measurements and the least squares fit for Test 23.

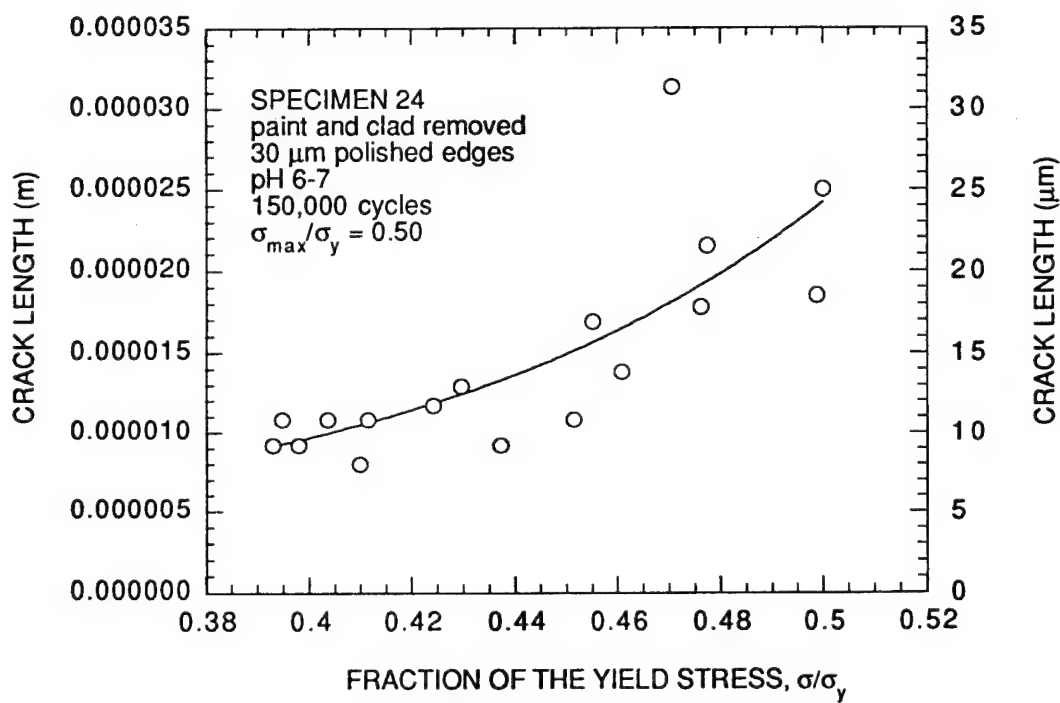
Figure A-18. Crack length data measurements and the least squares fit for Test 24.

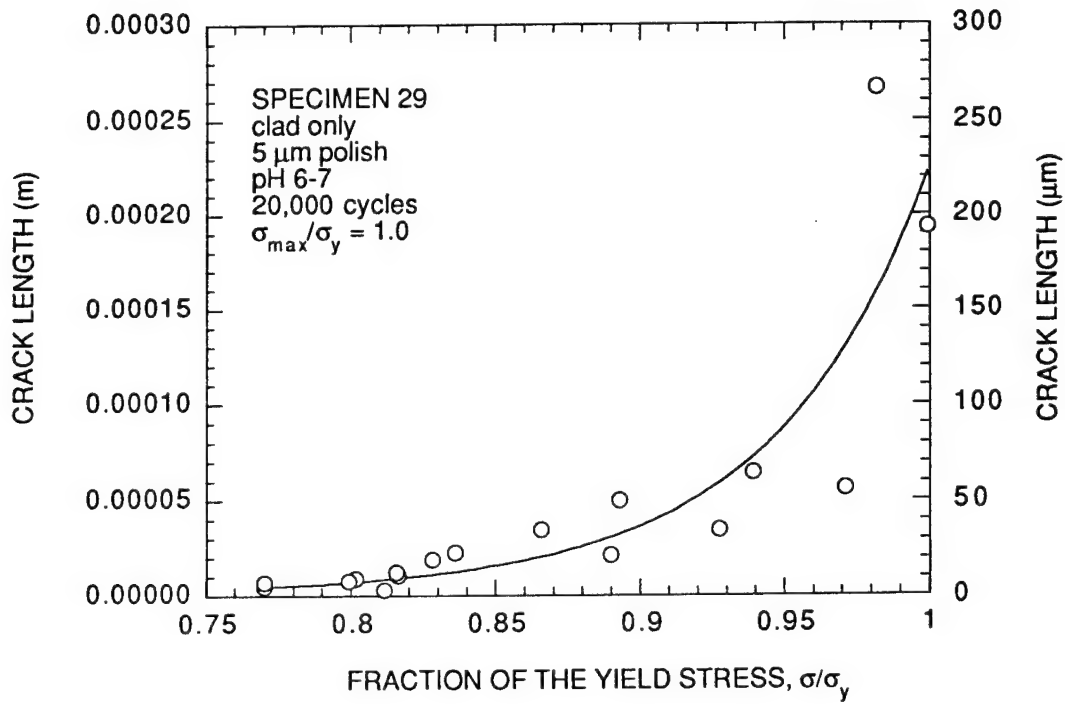
Figure A-19. Crack length data measurements and the least squares fit for Test 29.

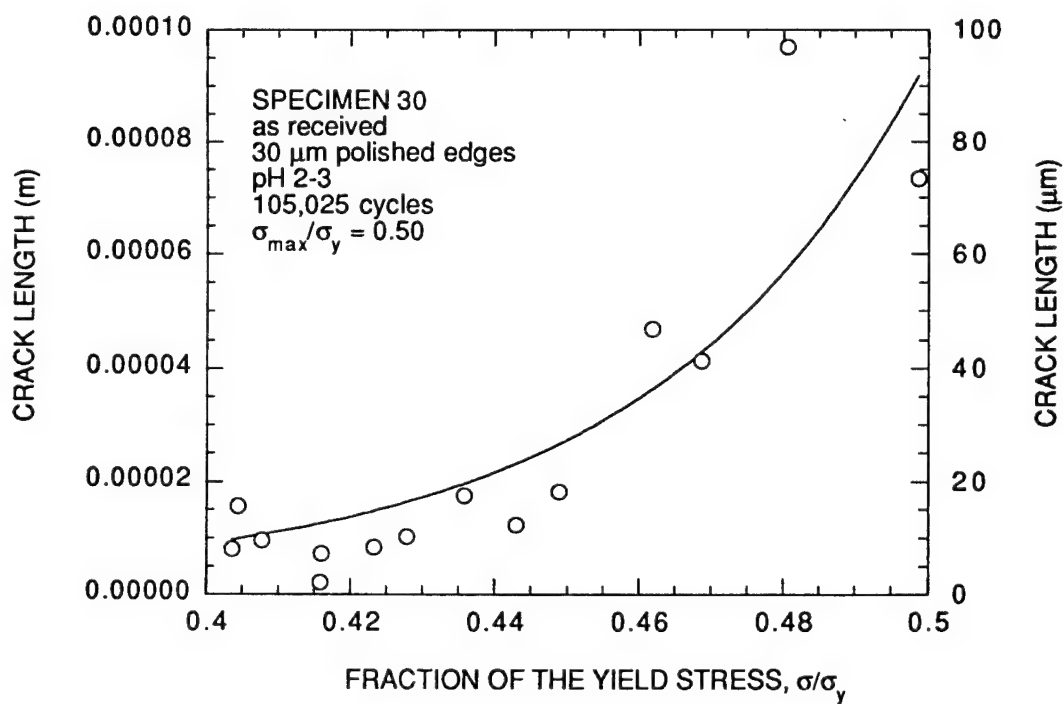
Figure A-20. Crack length data measurements and the least squares fit for Test 30.

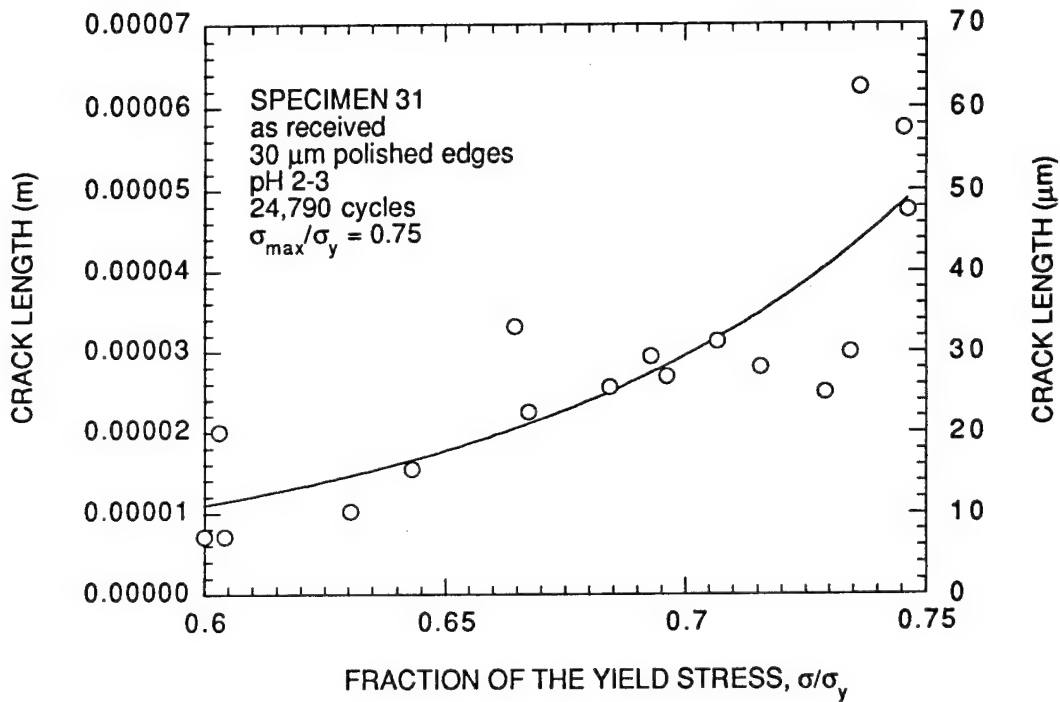
Figure A-21. Crack length data measurements and the least squares fit for Test 31.

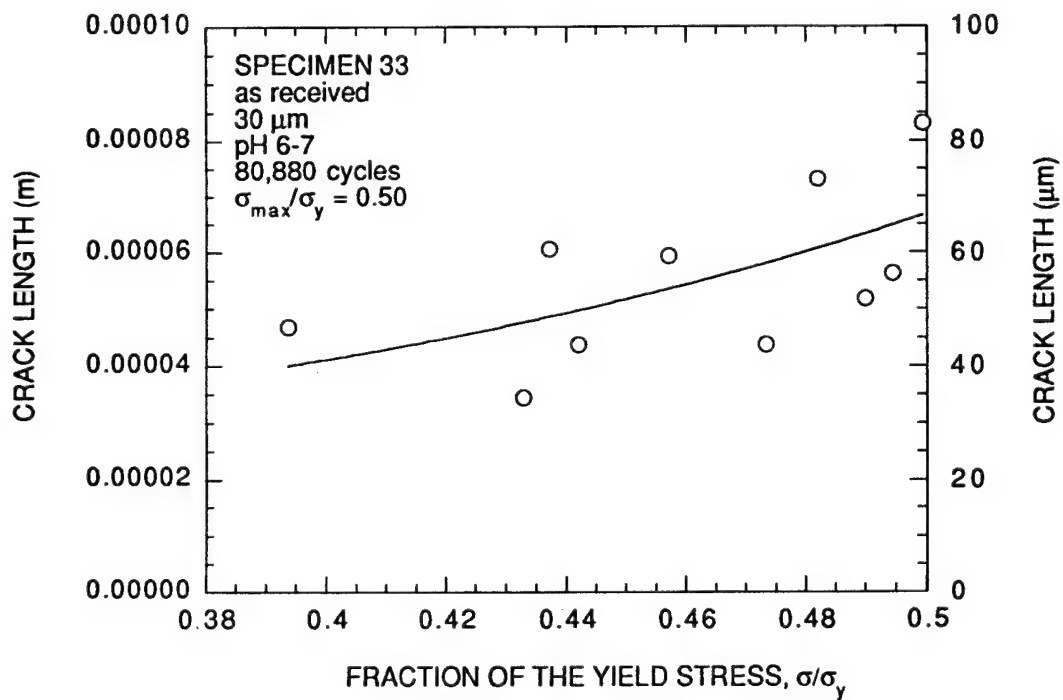
Figure A-22. Crack length data measurements and the least squares fit for Test 33.

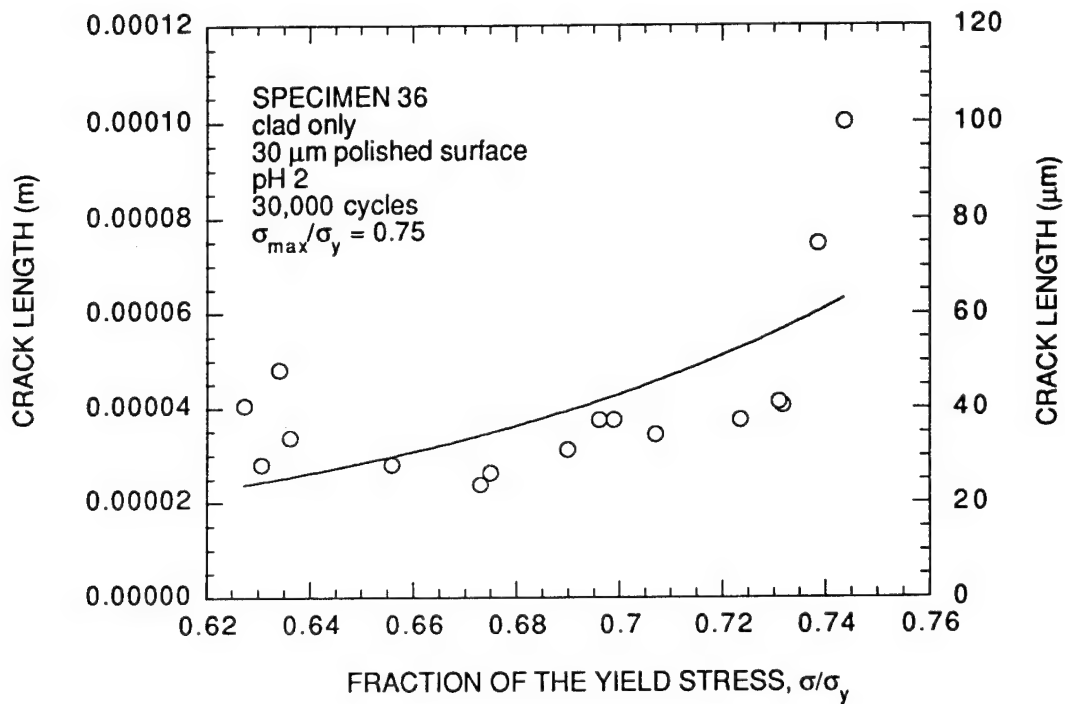
Figure A-23. Crack length data measurements and the least squares fit for Test 36.

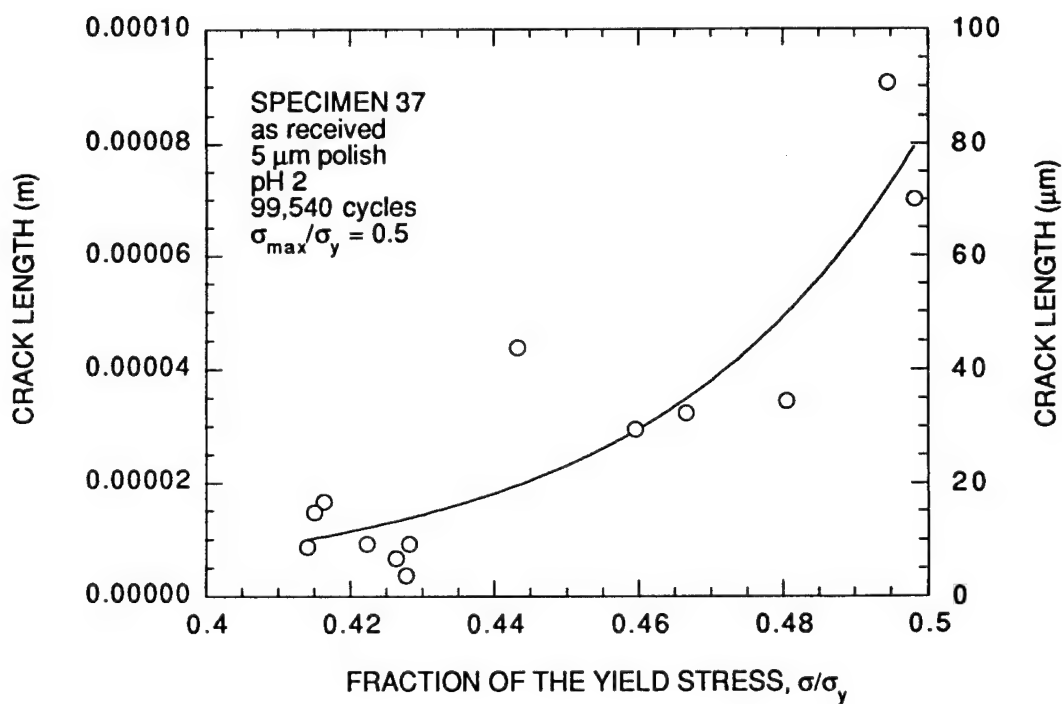
Figure A-24. Crack length data measurements and the least squares fit for Test 37.

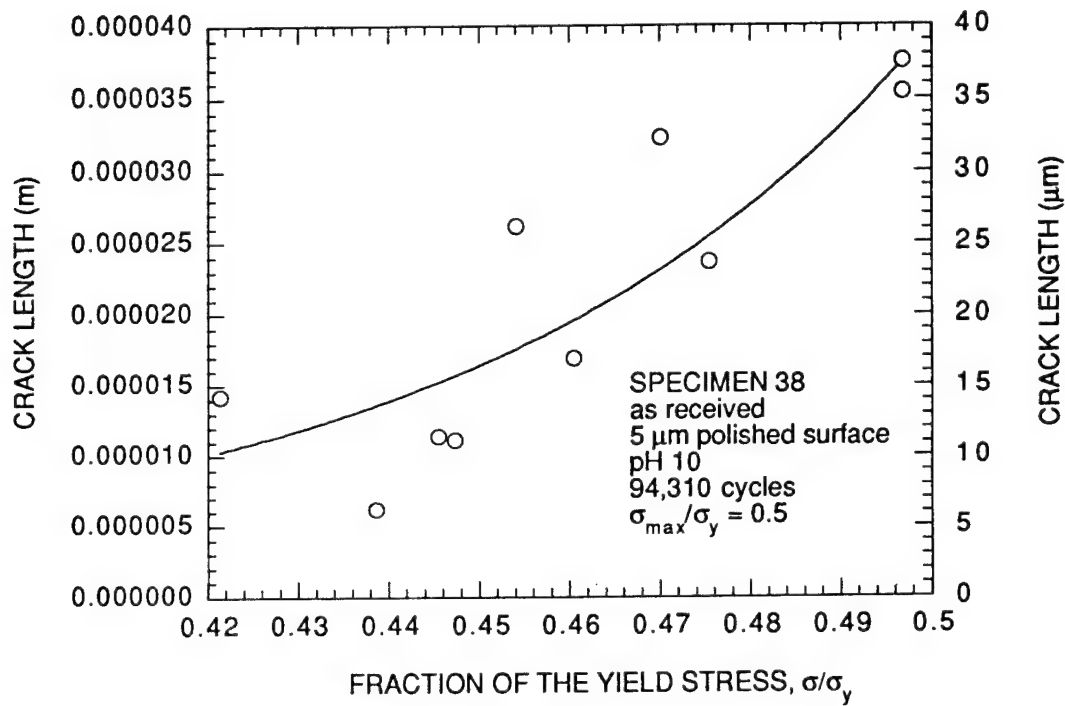
Figure A-25. Crack length data measurements and the least squares fit for Test 38.
